Tropicana Gold Mine Optimisation Project

Design brief Increase throughput from 6.5 Mtpa at 90% availability to 7.6 Mtpa at >95% availability.
Delivered 7.6 Mtpa throughput at >95% availability.

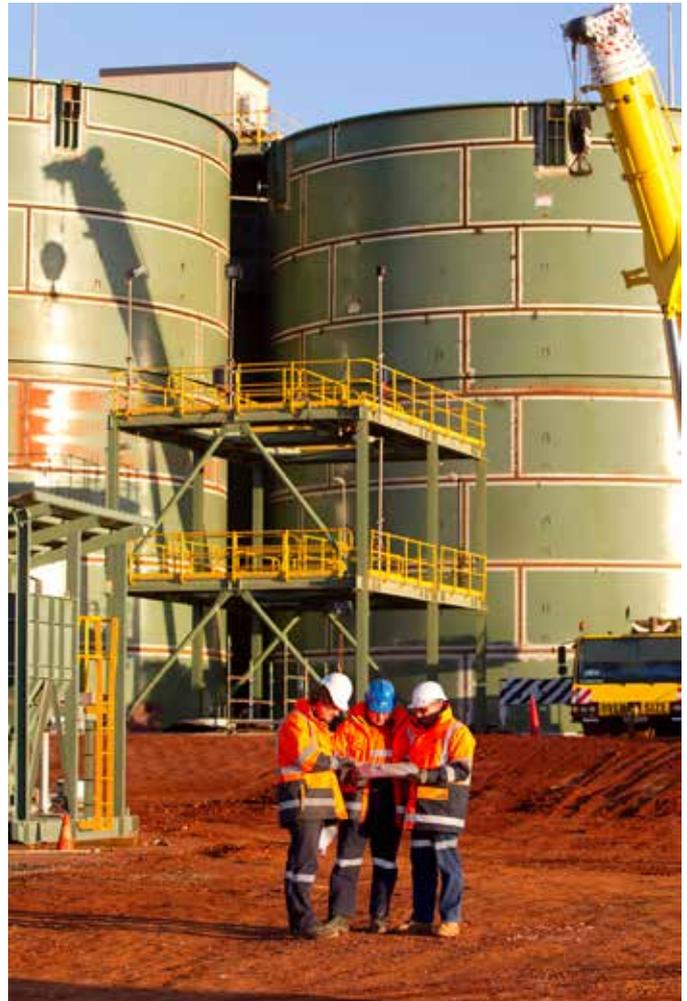
Figure 1: Construction of two additional leaching tanks

The debottlenecking process of the conveyors, bins and feeder restrictions and the construction of two additional leaching tanks provided immediate benefit by allowing an increase of the plant throughput whilst maintaining expected recovery.

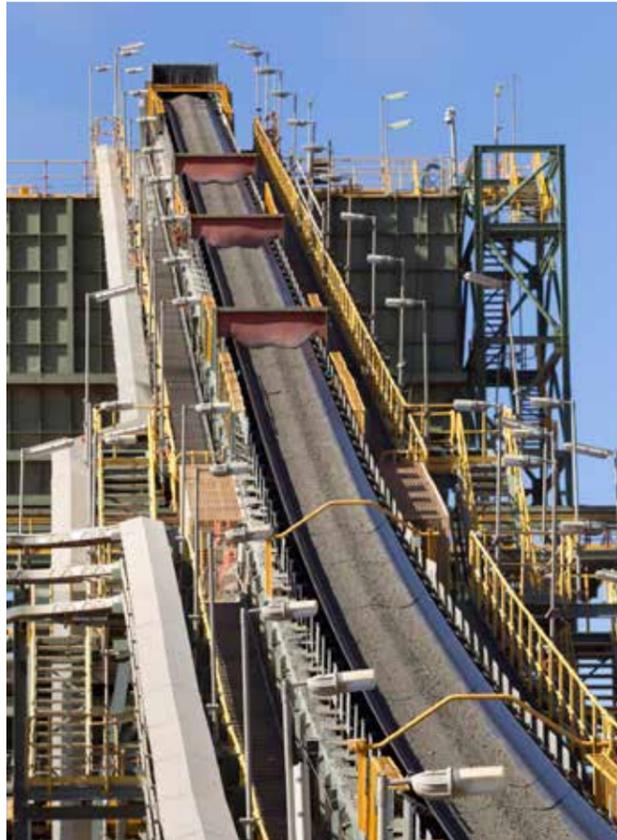
Figure 2: An optimised conveyor at the Tropicana Gold Mine

Unexpected material behaviour (such as ore rolling back on conveyor):

- Replacement of installed soft starters and fluid couplings with VVVF drives to extend the starting time;
- Installation of new gamma scale to monitor and control material sliding; and
- Reduction of take-up counter weight and conversion of pulley drive to ceramic lagging.

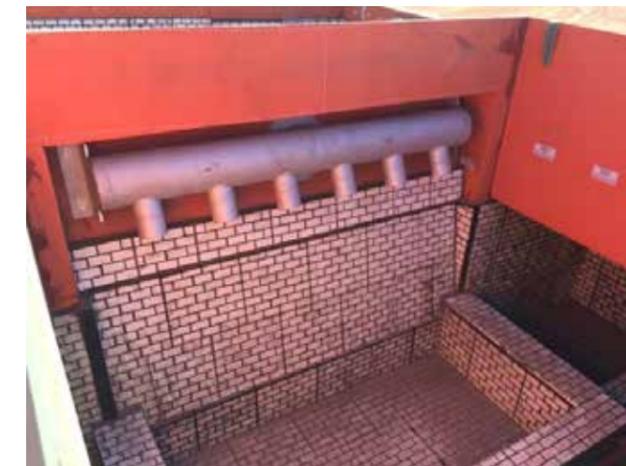
Figure 3: Ceramic lined pulping box

The newly designed pulping box has lasted more than 18 months with minimal maintenance requirements during shutdowns. Redesign of the water injection and arrangement of the flow into the box has improved pulping and drastically reduced the wear rate of the equipment. A new rotatable unit is in store with a replacement schedule implemented within the overall site shutdown strategy, taking less than 24 hours to change over.

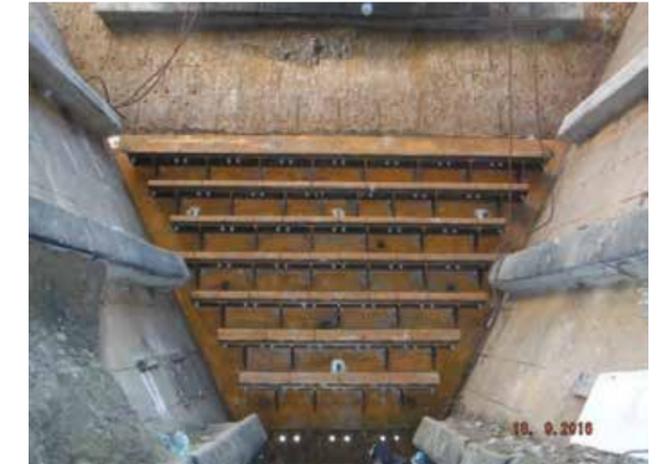
Figure 4: Modular one-piece drop in liner

Replacement of numerous small liner plates was a tedious task and in many cases was on the critical path for plant shutdowns. In consultation with the plant team, a large modular “one-piece drop-in” design liner was selected, for both bins, eliminating the need to change multiple small liner plates and thereby reducing servicing durations. The liners were replaced onsite utilising a 90 t slewing crane with some modifications to the top of bin structure.

It took 2 shifts of 12 hours each to modify and install the large liner. The upgraded liners have achieved a wear life in excess of 24 months and it will be possible to achieve the future liner replacement in less than 24 hours.
